**Flood Control Project Maintenance  
Levee Inspections**

**Fall 2019 Levee Maintenance Deficiency Summary Report**

**Sacramento River Basin**

**Lake County Watershed Protection District**

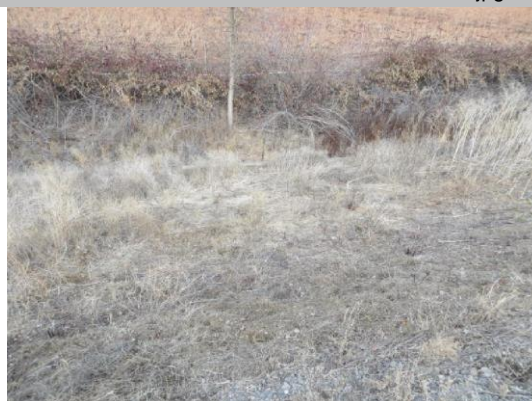
Photo 1 of 3 : UCIP\_FA\_2019\_55812\_49793.jpg

Comment Code						
Inspector Comment						
DS_ID:21236 FS_ID:55812 EP_NO: 11499 Repair Type: Non-Urgent Crossing Status: Found UCIP Comments: 10/16/2019 Record was updated from No Action Needed to Non-Urgent; need to audit record to confirm owner. Crossing has been internally inspected under the DWR DMP Phase 1 project. Inspection report is still not available. The UCIP inspection was completed with DWR Inspector, L. Dial, and LMA representative, S. Webb. (O. Magana - DWR UCIP) FIELD_STRUCT_DESC: 1 of 2: 42-inch corrugated metal drainage pipe through the levee, 12 feet below the crown. Flap gate on the waterside (WS) end. Concrete headwalls on both ends. (two 42-inch pipes [HLM 0.14] retained under Automatic Board Order (ABO) issued as Permit No. 11499, 1975 - Howard D. and Eunice A. Norton). [Additional Reference(s): DWR Levee Log, 2005. USACE Sacramento O&M Manual 506.2, August 1961, (HLM 0.14), Station DR8+60, two 42-inch pipes, dwg no. CC-4-4-29, Index Sheet 5: page 5, 39 of 64]. FS Date: 10/16/2019 4:01:00 PM

Concrete headwall visible on LS toe.

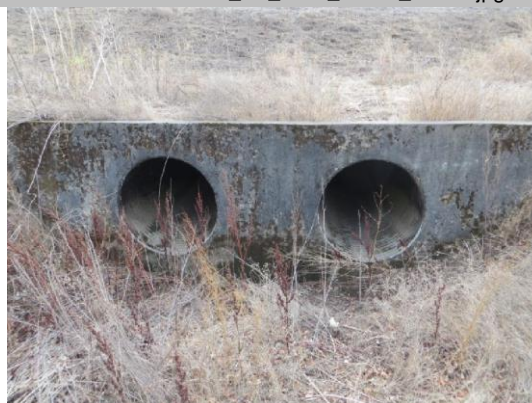
Photo 2 of 3 : UCIP\_FA\_2019\_55812\_49792.jpg

Concrete headwall visible on LS toe.

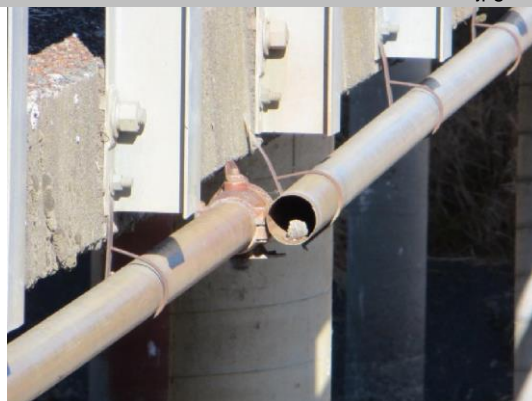
Photo 1 of 3 : UCIP\_FA\_2019\_55814\_49751.jpg

Comment Code						
Inspector Comment						
DS_ID:21226 FS_ID:55814 EP_NO: 6303A Repair Type: Non-Urgent Crossing Status: Found UCIP Comments: 10/16/2019 Record remains Non-Urgent; crossing has been abandoned. Owner will need to coordinate with CVFPB to remove or abandon crossing per Title 23 requirements. The UCIP inspection was completed with DWR Inspector, L. Dial, and LMA representative, S. Webb. (O. Magana - DWR UCIP)01/09/2014 Pipe open on waterward side and should be plugged. (W. Wylie - DWR UCIP) FIELD_STRUCT_DESC: 4-inch steel irrigation pipe through the levee, 1.5 feet below the crown. Steel cutoff wall around the pipe at center of levee. Pipe connects to 4-inch exposed aluminum pipe connected to upstream side of bridge. (4-inch water pipe authorized through both levees and suspended from the bridge authorized under Permit No. 6303-A, 1968 - John M. Siseuich). [Additional Reference(s): DWR Levee Log, 2005]. FS Date: 10/16/2019 4:02:00 PM

Pipe open on waterward end.

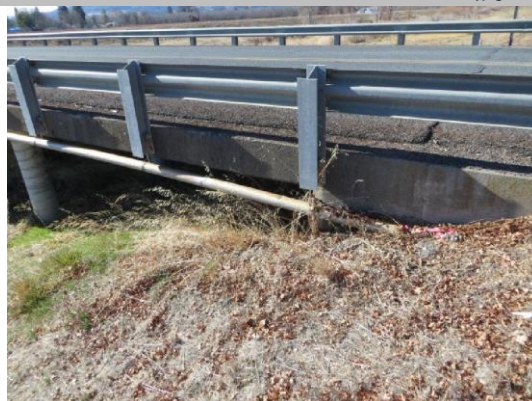
Photo 2 of 3 : UCIP\_FA\_2019\_55814\_49750.jpg

Pipe visible on upstream side of bridge.

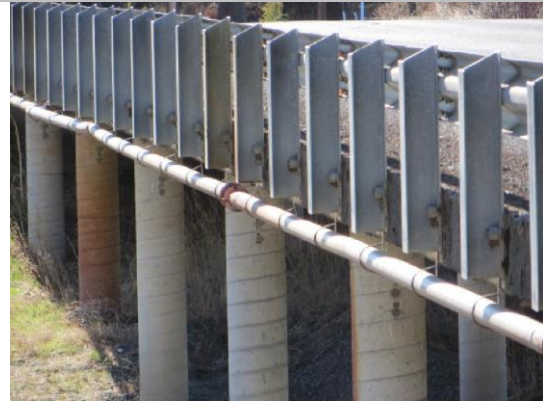
Photo 3 of 3 : UCIP\_FA\_2019\_55814\_49749.jpg

Item	DRAFT DWR UCIP Field Study			39.176410 °	39.176410 °
				-122.902740 °	-122.902740 °
DWR ID	21226				
Comment Code					
Inspector Comment					
DS_ID:21226 FS_ID:55814 EP_NO: 6303A Repair Type: Non-Urgent Crossing Status: Found UCIP Comments: 10/16/2019 Record remains Non-Urgent; crossing has been abandoned. Owner will need to coordinate with CVFPB to remove or abandon crossing per Title 23 requirements. The UCIP inspection was completed with DWR Inspector, L. Dial, and LMA representative, S. Webb. (O. Magana - DWR UCIP)01/09/2014 Pipe open on waterward side and should be plugged. (W. Wylie - DWR UCIP) FIELD_STRUCT_DESC: 4-inch steel irrigation pipe through the levee, 1.5 feet below the crown. Steel cutoff wall around the pipe at center of levee. Pipe connects to 4-inch exposed aluminum pipe connected to upstream side of bridge. (4-inch water pipe authorized through both levees and suspended from the bridge authorized under Permit No. 6303-A, 1968 - John M. Siseuich). [Additional Reference(s): DWR Levee Log, 2005]. FS Date: 10/16/2019 4:02:00 PM

Pipe visible on upstream side of bridge.

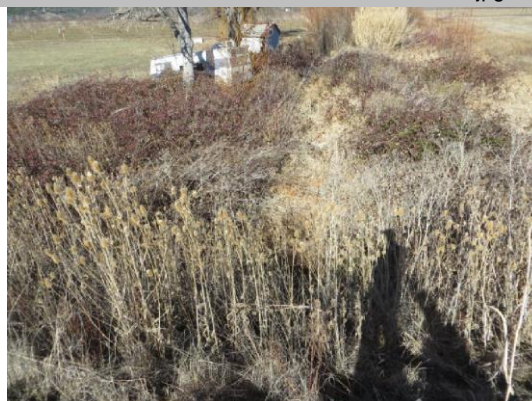
Photo 1 of 3 : UCIP\_FA\_2019\_55811\_49754.jpg

Comment Code						
Inspector Comment						
DS_ID:21227 FS_ID:55811 EP_NO: 11501 Repair Type: Urgent Crossing Status: Found UCIP Comments: 10/16/2019 Record remains Urgent due to evidence of pipe integrity issues on WS pipe collar. Need to audit record to confirm owner. Crossing has been internally inspected under the DWR DMP Phase 1 project. Inspection report is still not available. The UCIP inspection was completed with DWR Inspector, L. Dial, and LMA representative, S. Webb. (O. Magana - DWR UCIP)09/06/2018 Same as last inspection; crossing remains Urgent because of pipe integrity (D. Sanoski - DWR UCIP).11/30/2016 Clover Creek has significant sediment build up that blocks the outlet. Crossing is still in use to drain water from LS to WS according to LMA representative, Scott Webb. (O. Magana - DWR UCIP)01/09/2014 Pipe rusted through at connection to flap gate. Good indication pipe may need replacement. Video inspection recommended. (W. Wylie - DWR UCIP) FIELD_STRUCT_DESC: 24-inch corrugated metal (CM) drainage pipe through the levee, 13.8 feet below the crown. Flap gate is located on the waterside (WS) end. Concrete headwalls located on both the WS and landside (LS) ends. (24-inch pipe [HLM 0.77] was retained under Automatic Board Order (ABO) issued as Permit No. 11501, 1975 - Sisevich). [Additional Reference(s): DWR Levee Log, 2005. USACE Sacramento O&M Manual Unit 506.2, August 1961, (HLM 0.77), Station DR41+70, 24-inch pipe, dwg no. CC-4-4-29, Index Sheet 7: page 7, 41 of 64]. FS Date: 10/16/2019 4:01:00 PM

Drainage canal at inlet on LS toe.

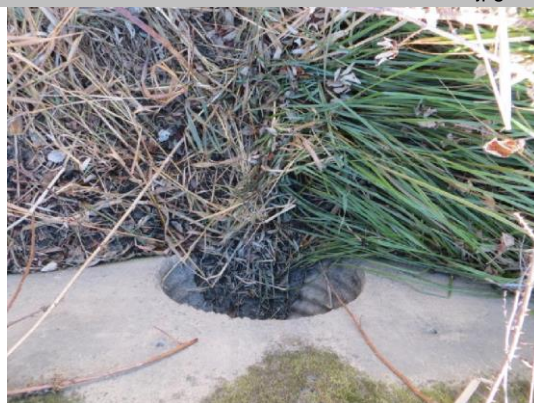
Photo 2 of 3 : UCIP\_FA\_2019\_55811\_49753.jpg

Comment Code						
Inspector Comment						
DS_ID:21227 FS_ID:55811 EP_NO: 11501 Repair Type: Urgent Crossing Status: Found UCIP Comments: 10/16/2019 Record remains Urgent due to evidence of pipe integrity issues on WS pipe collar. Need to audit record to confirm owner. Crossing has been internally inspected under the DWR DMP Phase 1 project. Inspection report is still not available. The UCIP inspection was completed with DWR Inspector, L. Dial, and LMA representative, S. Webb. (O. Magana - DWR UCIP)09/06/2018 Same as last inspection; crossing remains Urgent because of pipe integrity (D. Sanoski - DWR UCIP).11/30/2016 Clover Creek has significant sediment build up that blocks the outlet. Crossing is still in use to drain water from LS to WS according to LMA representative, Scott Webb. (O. Magana - DWR UCIP)01/09/2014 Pipe rusted through at connection to flap gate. Good indication pipe may need replacement. Video inspection recommended. (W. Wylie - DWR UCIP) FIELD_STRUCT_DESC: 24-inch corrugated metal (CM) drainage pipe through the levee, 13.8 feet below the crown. Flap gate is located on the waterside (WS) end. Concrete headwalls located on both the WS and landside (LS) ends. (24-inch pipe [HLM 0.77] was retained under Automatic Board Order (ABO) issued as Permit No. 11501, 1975 - Sisevich). [Additional Reference(s): DWR Levee Log, 2005. USACE Sacramento O&M Manual Unit 506.2, August 1961, (HLM 0.77), Station DR41+70, 24-inch pipe, dwg no. CC-4-4-29, Index Sheet 7: page 7, 41 of 64]. FS Date: 10/16/2019 4:01:00 PM

Pipe and concrete headwall visible in drainage channel on LS toe.

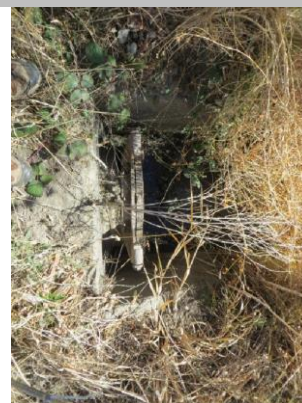
Photo 3 of 3 : UCIP\_FA\_2019\_55811\_49752.jpg

Comment Code						
Inspector Comment						
DS_ID:21227 FS_ID:55811 EP_NO: 11501 Repair Type: Urgent Crossing Status: Found UCIP Comments: 10/16/2019 Record remains Urgent due to evidence of pipe integrity issues on WS pipe collar. Need to audit record to confirm owner. Crossing has been internally inspected under the DWR DMP Phase 1 project. Inspection report is still not available. The UCIP inspection was completed with DWR Inspector, L. Dial, and LMA representative, S. Webb. (O. Magana - DWR UCIP)09/06/2018 Same as last inspection; crossing remains Urgent because of pipe integrity (D. Sanoski - DWR UCIP).11/30/2016 Clover Creek has significant sediment build up that blocks the outlet. Crossing is still in use to drain water from LS to WS according to LMA representative, Scott Webb. (O. Magana - DWR UCIP)01/09/2014 Pipe rusted through at connection to flap gate. Good indication pipe may need replacement. Video inspection recommended. (W. Wylie - DWR UCIP) FIELD_STRUCT_DESC: 24-inch corrugated metal (CM) drainage pipe through the levee, 13.8 feet below the crown. Flap gate is located on the waterside (WS) end. Concrete headwalls located on both the WS and landside (LS) ends. (24-inch pipe [HLM 0.77] was retained under Automatic Board Order (ABO) issued as Permit No. 11501, 1975 - Sisevich). [Additional Reference(s): DWR Levee Log, 2005. USACE Sacramento O&M Manual Unit 506.2, August 1961, (HLM 0.77), Station DR41+70, 24-inch pipe, dwg no. CC-4-4-29, Index Sheet 7: page 7, 41 of 64]. FS Date: 10/16/2019 4:01:00 PM

Flapgate at concrete headwall on WS toe.

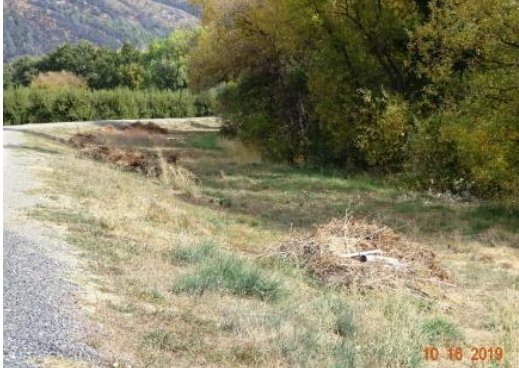
Photo 1 of 2 : FA\_2019\_NA0009\_6\_9\_20191018\_00021.jpg

View of prunings left on the waterside slope. Fall 2019

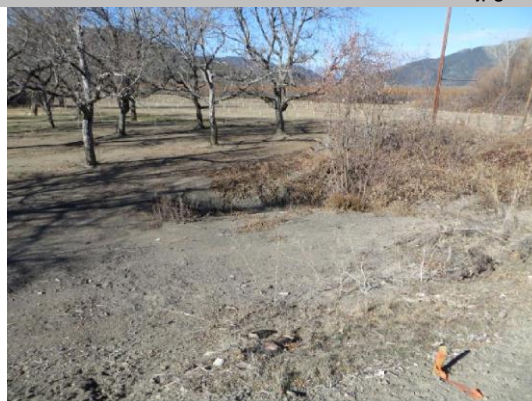
Photo 1 of 3 : UCIP\_FA\_2019\_55816\_49762.jpg

Comment Code						
Inspector Comment						
DS_ID:21228 FS_ID:55816 EP_NO: 11496 Repair Type: Urgent Crossing Status: Found UCIP Comments: 10/16/2019 Record was updated from No Action Needed to Urgent due to flap gate failure; flap gate does not seal properly which contributes to uncontrolled flow from WS to LS. Need to audit record to confirm owner. Also need to clear head of ditch to re-establish flow of ditch. Crossing has been internally inspected under the DWR DMP Phase 1 project. Inspection report is still not available. The UCIP inspection was completed with DWR Inspector, L. Dial, and LMA representative, S. Webb. (O. Magana - DWR UCIP) FIELD_STRUCT_DESC: 42-inch corrugated metal drainage pipe through the levee, 8 feet below the crown. Flap gate on the waterside (WS) end. Concrete headwalls on both ends. (24-inch pipes [HLM 1.21] retained under Automatic Board Order (ABO) issued as Permit No. 11496, 1975 - Earl Foutch). [Additional Reference(s): DWR Levee Log, 2005. USACE Sacramento O&M Manual 506.2, August 1961, (HLM 1.21), Station A15+50, 24-inch pipe referenced but 42-inch pipe constructed, dwg no. CC-4-4-29, Index Sheet 7: page 7, 41 of 64]. FS Date: 10/16/2019 4:03:00 PM

Drainpipe visible at LS toe.

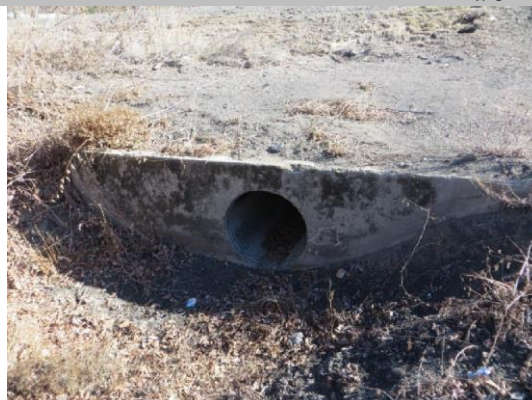
Photo 2 of 3 : UCIP\_FA\_2019\_55816\_49761.jpg

Concrete headwall and drainpipe visible at LS toe.

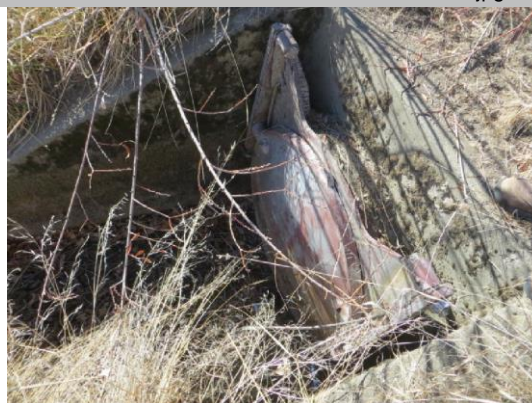
Photo 3 of 3 : UCIP\_FA\_2019\_55816\_49760.jpg

Comment Code						
Inspector Comment						
DS_ID:21228 FS_ID:55816 EP_NO: 11496 Repair Type: Urgent Crossing Status: Found UCIP Comments: 10/16/2019 Record was updated from No Action Needed to Urgent due to flap gate failure; flap gate does not seal properly which contributes to uncontrolled flow from WS to LS. Need to audit record to confirm owner. Also need to clear head of ditch to re-establish flow of ditch. Crossing has been internally inspected under the DWR DMP Phase 1 project. Inspection report is still not available. The UCIP inspection was completed with DWR Inspector, L. Dial, and LMA representative, S. Webb. (O. Magana - DWR UCIP) FIELD_STRUCT_DESC: 42-inch corrugated metal drainage pipe through the levee, 8 feet below the crown. Flap gate on the waterside (WS) end. Concrete headwalls on both ends. (24-inch pipes [HLM 1.21] retained under Automatic Board Order (ABO) issued as Permit No. 11496, 1975 - Earl Foutch). [Additional Reference(s): DWR Levee Log, 2005. USACE Sacramento O&M Manual 506.2, August 1961, (HLM 1.21), Station A15+50, 24-inch pipe referenced but 42-inch pipe constructed, dwg no. CC-4-4-29, Index Sheet 7: page 7, 41 of 64]. FS Date: 10/16/2019 4:03:00 PM

Concrete headwall visible off WS berm.

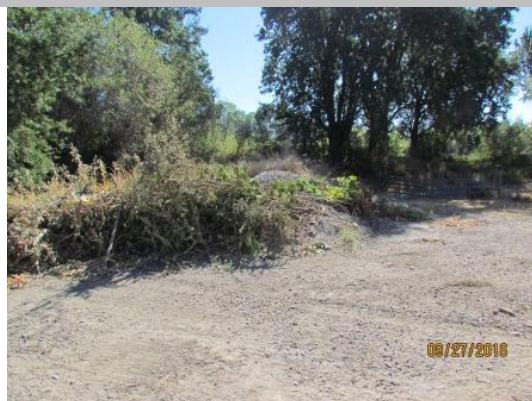
Photo 1 of 1 : FA\_2019\_NA0009\_6\_10\_20190904\_00002.jpg

LM Start	1.42	Rating **	M	Issue No.	10
LM End	1.42	Issue Type +	En	Location *	WS
Category	Earthen Levee			GPS Latitude/Longitude	
				Start	End
Item	Encroachments			39.185074 °	39.185074 °
				-122.893382 °	-122.893382 °
DWR ID	DWR_NA0009_04_f_2016_10				
Comment Code					
DE : Debris					
Inspector Comment

View of the prunings and soil pile on the waterside berm looking downstream. Fall 2016

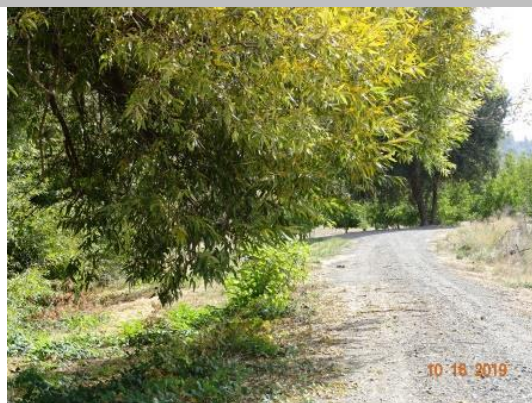
Photo 1 of 1 : FA\_2019\_NA0009\_7\_11\_20191021\_00030.jpg

LM Start	0.04	Rating **	M	Issue No.	11
LM End	0.04	Issue Type +	Ma	Location *	WS
Category	Earthen Levee			GPS Latitude/Longitude	
				Start	End
Item	Trim / Thin Trees			39.177086 °	39.177086 °
				-122.894018 °	-122.894018 °
DWR ID	DWR_NA0009_05_s_2019_11				
Comment Code					
T1 : Trim trees to at least five feet above ground level.					
Inspector Comment

View of low tree branches hanging over the crown and slope. Fall 2019

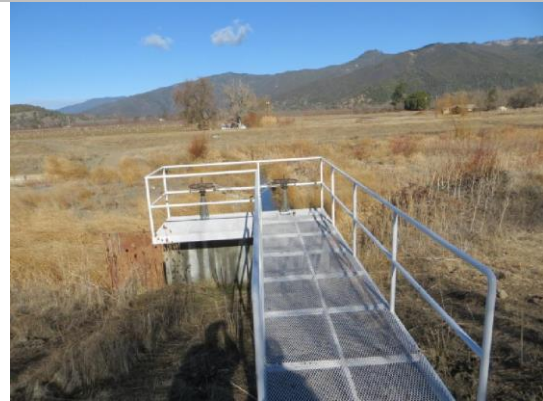
Photo 1 of 3 : UCIP\_FA\_2019\_55848\_49712.jpg

DS\_ID:21235  
FS\_ID:55848  
EP\_NO: 11507  
Repair Type: Non-Urgent  
Crossing Status: Found  
UCIP Comments: 11/20/2019 Received update from LMA representative, S. Webb, regarding the removal of the gravel bar at the Clover Creek Diversion Structure completed in late October-2019. Photos of the clearing have been uploaded. Record remains Non-Urgent; need to clarify owner for this structure. (O. Magana - DWR UCIP) 10/16/2019 Crossing remains Non-Urgent due to a non-functional structure. As noted in the DWR Levee Annual Inspection report dated June 2019, significant gravel bar is impeding the flow of the channel. The new channel u/s created from the gravel reroutes low flows past the structure. According to LMA representative, S. Webb, this structure might be over designed. Mr. Webb would like to explore potential modifications to the Clover Creek Diversion Structure [six 36-inch pipes]. The proposed modification would include adding a slide gate to the most d/s pipe (designated as pipe 6) and use that one to control summer flows in conjunction the concrete weir. The pipes designated as 3, 4, and 5 (u/s to d/s, middle pipes) would not be necessary and would require proper abandonment. Pipes designated as 1 and 2 with slide gates would remain in use and would be used to allow the clear lake hitch fish to migrate u/s of the tributary. Currently, four of the six pipes without slide gates have metal sheet covering the inlet which prevent flows (flooding) from WS to LS. The structure has been designated for internal video inspection and has been scheduled for December 2019. Recommend having the CVFPB audit ABO to clarify owner. The UCIP inspection was completed with DWR Inspector, L. Dial, and DWR Sutter Yard Supervisor, S. Webb. (O. Magana - DWR UCIP)10/27/2017 This structure is inspected annually under the Structure and Channel Summer Inspection (part of the Levee Inspection Program) conducted by the DWR Flood Project Integrity and Inspection Branch (FPIIB). (DWR UCIP - O. Magana) 01/09/2014 Some sediment buildup at LS toe. (W. Wylie - DWR UCIP) FIELD\_STRUCT\_DESC: [Clover Creek Diversion Structure] 1 of 6: 36-inch corrugated metal drainage pipe through the levee, 12 feet below the crown. Slide gate on the waterside (WS) end. Steel walkway on the WS slope to slide gate. Concrete headwall on both ends. (six 36-inch pipes and structure [HLM 0.3] retained under Automatic Board Order (ABO) issued as Permit No. 11507, 1975 - Lake County Flood Control and Water Conservation District). [Additional Reference(s): DWR Levee Log, 2005. USACE Sacramento O&M Manual 506, Part 2, August 1961, (HLM 0.31), Station DR40+19 to DR41+10, six 36-inch pipes referenced as Clover Creek Outlet Works, dwg no. CC-4-4-29, Index Sheet 7: page 7, 41 of 64 and Sheet 29/20-21, page 53, 54 of 64].

Slide gate at steel walkway on WS toe.

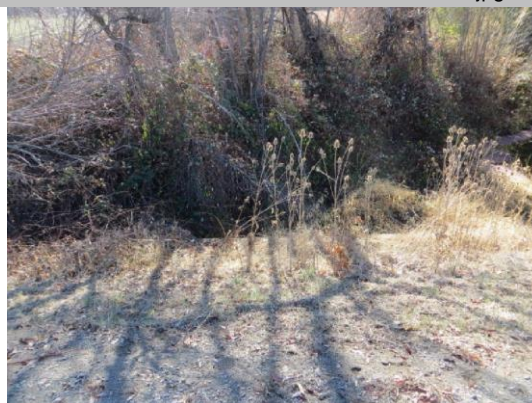
Photo 2 of 3 : UCIP\_FA\_2019\_55848\_49711.jpg

DS\_ID:21235  
FS\_ID:55848  
EP\_NO: 11507  
Repair Type: Non-Urgent  
Crossing Status: Found  
UCIP Comments: 11/20/2019 Received update from LMA representative, S. Webb, regarding the removal of the gravel bar at the Clover Creek Diversion Structure completed in late October-2019. Photos of the clearing have been uploaded. Record remains Non-Urgent; need to clarify owner for this structure. (O. Magana - DWR UCIP) 10/16/2019 Crossing remains Non-Urgent due to a non-functional structure. As noted in the DWR Levee Annual Inspection report dated June 2019, significant gravel bar is impeding the flow of the channel. The new channel u/s created from the gravel reroutes low flows past the structure. According to LMA representative, S. Webb, this structure might be over designed. Mr. Webb would like to explore potential modifications to the Clover Creek Diversion Structure [six 36-inch pipes]. The proposed modification would include adding a slide gate to the most d/s pipe (designated as pipe 6) and use that one to control summer flows in conjunction the concrete weir. The pipes designated as 3, 4, and 5 (u/s to d/s, middle pipes) would not be necessary and would require proper abandonment. Pipes designated as 1 and 2 with slide gates would remain in use and would be used to allow the clear lake hitch fish to migrate u/s of the tributary. Currently, four of the six pipes without slide gates have metal sheet covering the inlet which prevent flows (flooding) from WS to LS. The structure has been designated for internal video inspection and has been scheduled for December 2019. Recommend having the CVFPB audit ABO to clarify owner. The UCIP inspection was completed with DWR Inspector, L. Dial, and DWR Sutter Yard Supervisor, S. Webb. (O. Magana - DWR UCIP)10/27/2017 This structure is inspected annually under the Structure and Channel Summer Inspection (part of the Levee Inspection Program) conducted by the DWR Flood Project Integrity and Inspection Branch (FPIIB). (DWR UCIP - O. Magana) 01/09/2014 Some sediment buildup at LS toe. (W. Wylie - DWR UCIP) FIELD\_STRUCT\_DESC: [Clover Creek Diversion Structure] 1 of 6: 36-inch corrugated metal drainage pipe through the levee, 12 feet below the crown. Slide gate on the waterside (WS) end. Steel walkway on the WS slope to slide gate. Concrete headwall on both ends. (six 36-inch pipes and structure [HLM 0.3] retained under Automatic Board Order (ABO) issued as Permit No. 11507, 1975 - Lake County Flood Control and Water Conservation District). [Additional Reference(s): DWR Levee Log, 2005. USACE Sacramento O&M Manual 506, Part 2, August 1961, (HLM 0.31), Station DR40+19 to DR41+10, six 36-inch pipes referenced as Clover Creek Outlet Works, dwg no. CC-4-4-29, Index Sheet 7: page 7, 41 of 64 and Sheet 29/20-21, page 53, 54 of 64].

Outlet visible at concrete headwall on LS toe.

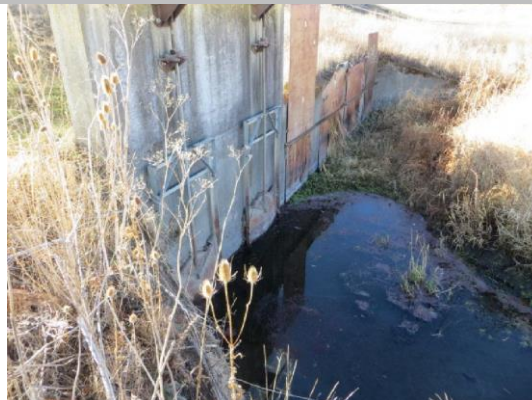
Photo 3 of 3 : UCIP\_FA\_2019\_55848\_49710.jpg

DS\_ID:21235  
FS\_ID:55848  
EP\_NO: 11507  
Repair Type: Non-Urgent  
Crossing Status: Found  
UCIP Comments: 11/20/2019 Received update from LMA representative, S. Webb, regarding the removal of the gravel bar at the Clover Creek Diversion Structure completed in late October-2019. Photos of the clearing have been uploaded. Record remains Non-Urgent; need to clarify owner for this structure. (O. Magana - DWR UCIP) 10/16/2019 Crossing remains Non-Urgent due to a non-functional structure. As noted in the DWR Levee Annual Inspection report dated June 2019, significant gravel bar is impeding the flow of the channel. The new channel u/s created from the gravel reroutes low flows past the structure. According to LMA representative, S. Webb, this structure might be over designed. Mr. Webb would like to explore potential modifications to the Clover Creek Diversion Structure [six 36-inch pipes]. The proposed modification would include adding a slide gate to the most d/s pipe (designated as pipe 6) and use that one to control summer flows in conjunction the concrete weir. The pipes designated as 3, 4, and 5 (u/s to d/s, middle pipes) would not be necessary and would require proper abandonment. Pipes designated as 1 and 2 with slide gates would remain in use and would be used to allow the clear lake hitch fish to migrate u/s of the tributary. Currently, four of the six pipes without slide gates have metal sheet covering the inlet which prevent flows (flooding) from WS to LS. The structure has been designated for internal video inspection and has been scheduled for December 2019. Recommend having the CVFPB audit ABO to clarify owner. The UCIP inspection was completed with DWR Inspector, L. Dial, and DWR Sutter Yard Supervisor, S. Webb. (O. Magana - DWR UCIP)10/27/2017 This structure is inspected annually under the Structure and Channel Summer Inspection (part of the Levee Inspection Program) conducted by the DWR Flood Project Integrity and Inspection Branch (FPIIB). (DWR UCIP - O. Magana) 01/09/2014 Some sediment buildup at LS toe. (W. Wylie - DWR UCIP) FIELD\_STRUCT\_DESC: [Clover Creek Diversion Structure] 1 of 6: 36-inch corrugated metal drainage pipe through the levee, 12 feet below the crown. Slide gate on the waterside (WS) end. Steel walkway on the WS slope to slide gate. Concrete headwall on both ends. (six 36-inch pipes and structure [HLM 0.3] retained under Automatic Board Order (ABO) issued as Permit No. 11507, 1975 - Lake County Flood Control and Water Conservation District). [Additional Reference(s): DWR Levee Log, 2005. USACE Sacramento O&M Manual 506, Part 2, August 1961, (HLM 0.31), Station DR40+19 to DR41+10, six 36-inch pipes referenced as Clover Creek Outlet Works, dwg no. CC-4-4-29, Index Sheet 7: page 7, 41 of 64 and Sheet 29/20-21, page 53, 54 of 64].

Slide gate at concrete headwall on WS toe.

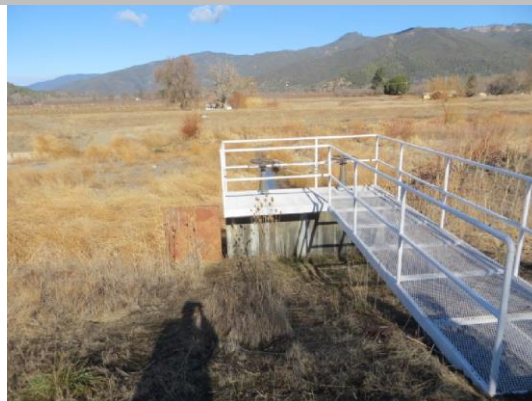
Photo 1 of 3 : UCIP\_FA\_2019\_55849\_49682.jpg

DS\_ID:21234  
FS\_ID:55849  
EP\_NO: 11507  
Repair Type: Non-Urgent  
Crossing Status: Found  
UCIP Comments: 11/20/2019 Received update from LMA representative, S. Webb, regarding the removal of the gravel bar at the Clover Creek Diversion Structure completed in late October-2019. Photos of the clearing have been uploaded. Record remains Non-Urgent; need to clarify owner for this structure. (O. Magana - DWR UCIP)10/16/2019 Crossing remains Non-Urgent due to a non-functional structure. As noted in the DWR Levee Annual Inspection report dated June 2019, significant gravel bar is impeding the flow of the channel. The new channel u/s created from the gravel reroutes low flows past the structure. According to LMA representative, S. Webb, this structure might be over designed. Mr. Webb would like to explore potential modifications to the Clover Creek Diversion Structure [six 36-inch pipes]. The proposed modification would include adding a slide gate to the most d/s pipe (designated as pipe 6) and use that one to control summer flows in conjunction the concrete weir. The pipes designated as 3, 4, and 5 (u/s to d/s, middle pipes) would not be necessary and would require proper abandonment. Pipes designated as 1 and 2 with slide gates would remain in use and would be used to allow the clear lake hitch fish to migrate u/s of the tributary. Currently, four of the six pipes without slide gates have metal sheet covering the inlet which prevent flows (flooding) from WS to LS. The structure has been designated for internal video inspection and has been scheduled for December 2019. Recommend having the CVFPB audit ABO to clarify owner. The UCIP inspection was completed with DWR Inspector, L. Dial, and DWR Sutter Yard Supervisor, S. Webb. (O. Magana - DWR UCIP)10/27/2017 This structure is inspected annually under the Structure and Channel Summer Inspection (part of the Levee Inspection Program) conducted by the DWR Flood Project Integrity and Inspection Branch (FPIIB). (DWR UCIP - O. Magana) 01/09/2014 Some sediment buildup on LS toe. (W. Wylie - DWR UCIP) FIELD\_STRUCT\_DESC: [Clover Creek Diversion Structure] 2 of 6: 36-inch corrugated metal drainage pipe through the levee, 12 feet below the crown. Slide gate on the waterside (WS) end. Steel walkway on the WS slope to slide gate. Concrete headwalls on both ends. (six 36-inch pipes and structure [HLM 0.3] retained under Automatic Board Order (ABO) issued as Permit No. 11507, 1975 - Lake County Flood Control and Water Conservation District). [Additional Reference(s): DWR Levee Log, 2005. USACE Sacramento O&M Manual 506, Part 2, August 1961, (HLM 0.31)].

Slide gate on steel walkway at WS toe.

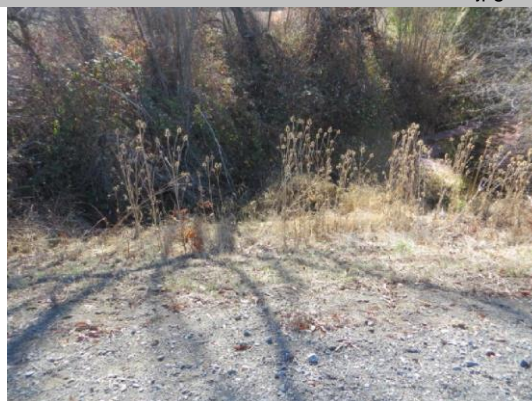
Photo 2 of 3 : UCIP\_FA\_2019\_55849\_49681.jpg

DS\_ID:21234  
FS\_ID:55849  
EP\_NO: 11507  
Repair Type: Non-Urgent  
Crossing Status: Found  
UCIP Comments: 11/20/2019 Received update from LMA representative, S. Webb, regarding the removal of the gravel bar at the Clover Creek Diversion Structure completed in late October-2019. Photos of the clearing have been uploaded. Record remains Non-Urgent; need to clarify owner for this structure. (O. Magana - DWR UCIP)10/16/2019 Crossing remains Non-Urgent due to a non-functional structure. As noted in the DWR Levee Annual Inspection report dated June 2019, significant gravel bar is impeding the flow of the channel. The new channel u/s created from the gravel reroutes low flows past the structure. According to LMA representative, S. Webb, this structure might be over designed. Mr. Webb would like to explore potential modifications to the Clover Creek Diversion Structure [six 36-inch pipes]. The proposed modification would include adding a slide gate to the most d/s pipe (designated as pipe 6) and use that one to control summer flows in conjunction the concrete weir. The pipes designated as 3, 4, and 5 (u/s to d/s, middle pipes) would not be necessary and would require proper abandonment. Pipes designated as 1 and 2 with slide gates would remain in use and would be used to allow the clear lake hitch fish to migrate u/s of the tributary. Currently, four of the six pipes without slide gates have metal sheet covering the inlet which prevent flows (flooding) from WS to LS. The structure has been designated for internal video inspection and has been scheduled for December 2019. Recommend having the CVFPB audit ABO to clarify owner. The UCIP inspection was completed with DWR Inspector, L. Dial, and DWR Sutter Yard Supervisor, S. Webb. (O. Magana - DWR UCIP)10/27/2017 This structure is inspected annually under the Structure and Channel Summer Inspection (part of the Levee Inspection Program) conducted by the DWR Flood Project Integrity and Inspection Branch (FPIIB). (DWR UCIP - O. Magana) 01/09/2014 Some sediment buildup on LS toe. (W. Wylie - DWR UCIP) FIELD\_STRUCT\_DESC: [Clover Creek Diversion Structure] 2 of 6: 36-inch corrugated metal drainage pipe through the levee, 12 feet below the crown. Slide gate on the waterside (WS) end. Steel walkway on the WS slope to slide gate. Concrete headwalls on both ends. (six 36-inch pipes and structure [HLM 0.3] retained under Automatic Board Order (ABO) issued as Permit No. 11507, 1975 - Lake County Flood Control and Water Conservation District). [Additional Reference(s): DWR Levee Log, 2005. USACE Sacramento O&M Manual 506, Part 2, August 1961, (HLM 0.31)].

Outlet visible at concrete headwall on LS toe.

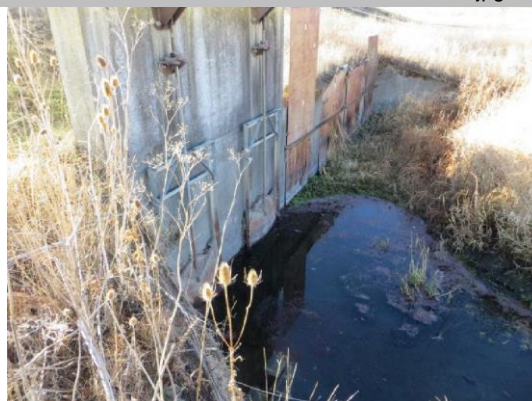
Photo 3 of 3 : UCIP\_FA\_2019\_55849\_49680.jpg

DS\_ID:21234  
FS\_ID:55849  
EP\_NO: 11507  
Repair Type: Non-Urgent  
Crossing Status: Found  
UCIP Comments: 11/20/2019 Received update from LMA representative, S. Webb, regarding the removal of the gravel bar at the Clover Creek Diversion Structure completed in late October-2019. Photos of the clearing have been uploaded. Record remains Non-Urgent; need to clarify owner for this structure. (O. Magana - DWR UCIP)10/16/2019 Crossing remains Non-Urgent due to a non-functional structure. As noted in the DWR Levee Annual Inspection report dated June 2019, significant gravel bar is impeding the flow of the channel. The new channel u/s created from the gravel reroutes low flows past the structure. According to LMA representative, S. Webb, this structure might be over designed. Mr. Webb would like to explore potential modifications to the Clover Creek Diversion Structure [six 36-inch pipes]. The proposed modification would include adding a slide gate to the most d/s pipe (designated as pipe 6) and use that one to control summer flows in conjunction the concrete weir. The pipes designated as 3, 4, and 5 (u/s to d/s, middle pipes) would not be necessary and would require proper abandonment. Pipes designated as 1 and 2 with slide gates would remain in use and would be used to allow the clear lake hitch fish to migrate u/s of the tributary. Currently, four of the six pipes without slide gates have metal sheet covering the inlet which prevent flows (flooding) from WS to LS. The structure has been designated for internal video inspection and has been scheduled for December 2019. Recommend having the CVFPB audit ABO to clarify owner. The UCIP inspection was completed with DWR Inspector, L. Dial, and DWR Sutter Yard Supervisor, S. Webb. (O. Magana - DWR UCIP)10/27/2017 This structure is inspected annually under the Structure and Channel Summer Inspection (part of the Levee Inspection Program) conducted by the DWR Flood Project Integrity and Inspection Branch (FPIIB). (DWR UCIP - O. Magana) 01/09/2014 Some sediment buildup on LS toe. (W. Wylie - DWR UCIP) FIELD\_STRUCT\_DESC: [Clover Creek Diversion Structure] 2 of 6: 36-inch corrugated metal drainage pipe through the levee, 12 feet below the crown. Slide gate on the waterside (WS) end. Steel walkway on the WS slope to slide gate. Concrete headwalls on both ends. (six 36-inch pipes and structure [HLM 0.3] retained under Automatic Board Order (ABO) issued as Permit No. 11507, 1975 - Lake County Flood Control and Water Conservation District). [Additional Reference(s): DWR Levee Log, 2005. USACE Sacramento O&M Manual 506, Part 2, August 1961, (HLM 0.31)].

Slide gate visible at concrete headwall on WS toe.

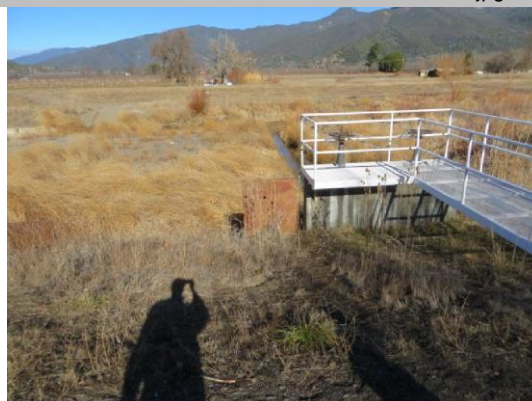
Photo 1 of 3 : UCIP\_FA\_2019\_55853\_49666.jpg

DS\_ID:21233  
FS\_ID:55853  
EP\_NO: 11507  
Repair Type: Non-Urgent  
Crossing Status: Found  
UCIP Comments: 11/20/2019 Received update from LMA representative, S. Webb, regarding the removal of the gravel bar at the Clover Creek Diversion Structure completed in late October-2019. Photos of the clearing have been uploaded. Record remains Non-Urgent; need to clarify owner for this structure. (O. Magana - DWR UCIP)10/16/2019 Crossing remains Non-Urgent due to a non-functional structure. As noted in the DWR Levee Annual Inspection report dated June 2019, significant gravel bar is impeding the flow of the channel. The new channel u/s created from the gravel reroutes low flows past the structure. According to LMA representative, S. Webb, this structure might be over designed. Mr. Webb would like to explore potential modifications to the Clover Creek Diversion Structure [six 36-inch pipes]. The proposed modification would include adding a slide gate to the most d/s pipe (designated as pipe 6) and use that one to control summer flows in conjunction the concrete weir. The pipes designated as 3, 4, and 5 (u/s to d/s, middle pipes) would not be necessary and would require proper abandonment. Pipes designated as 1 and 2 with slide gates would remain in use and would be used to allow the clear lake hitch fish to migrate u/s of the tributary. Currently, four of the six pipes without slide gates have metal sheet covering the inlet which prevent flows (flooding) from WS to LS. The structure has been designated for internal video inspection and has been scheduled for December 2019. Recommend having the CVFPB audit ABO to clarify owner. The UCIP inspection was completed with DWR Inspector, L. Dial, and DWR Sutter Yard Supervisor, S. Webb. (O. Magana - DWR UCIP)10/27/2017 This structure is inspected annually under the Structure and Channel Summer Inspection (part of the Levee Inspection Program) conducted by the DWR Flood Project Integrity and Inspection Branch (FPIIB). (DWR UCIP - O. Magana) 01/09/2014 Some sediment buildup at outlet on LS toe. (W. Wylie - DWR UCIP)

Steel slide gate visible at concrete headwall on WS toe.

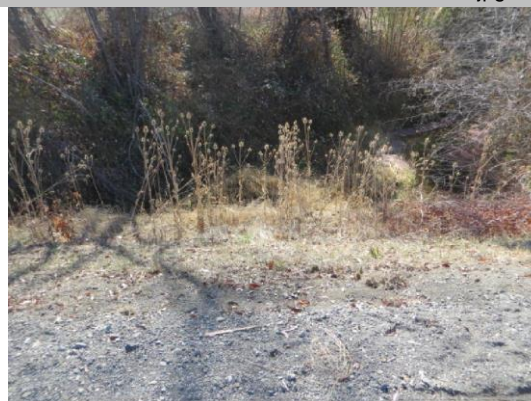
Photo 2 of 3 : UCIP\_FA\_2019\_55853\_49665.jpg

Outlet visible at concrete headwall on LS toe.

DWR ID	21233
Comment Code	
Inspector Comment	
<p>DS_ID:21233 FS_ID:55853 EP_NO: 11507 Repair Type: Non-Urgent Crossing Status: Found UCIP Comments: 11/20/2019 Received update from LMA representative, S. Webb, regarding the removal of the gravel bar at the Clover Creek Diversion Structure completed in late October-2019. Photos of the clearing have been uploaded. Record remains Non-Urgent; need to clarify owner for this structure. (O. Magana - DWR UCIP)10/16/2019 Crossing remains Non-Urgent due to a non-functional structure. As noted in the DWR Levee Annual Inspection report dated June 2019, significant gravel bar is impeding the flow of the channel. The new channel u/s created from the gravel reroutes low flows past the structure. According to LMA representative, S. Webb, this structure might be over designed. Mr. Webb would like to explore potential modifications to the Clover Creek Diversion Structure [six 36-inch pipes]. The proposed modification would include adding a slide gate to the most d/s pipe (designated as pipe 6) and use that one to control summer flows in conjunction the concrete weir. The pipes designated as 3, 4, and 5 (u/s to d/s, middle pipes) would not be necessary and would require proper abandonment. Pipes designated as 1 and 2 with slide gates would remain in use and would be used to allow the clear lake hitch fish to migrate u/s of the tributary. Currently, four of the six pipes without slide gates have metal sheet covering the inlet which prevent flows (flooding) from WS to LS. The structure has been designated for internal video inspection and has been scheduled for December 2019. Recommend having the CVFPB audit ABO to clarify owner. The UCIP inspection was completed with DWR Inspector, L. Dial, and DWR Sutter Yard Supervisor, S. Webb. (O. Magana - DWR UCIP)10/27/2017 This structure is inspected annually under the Structure and Channel Summer Inspection (part of the Levee Inspection Program) conducted by the DWR Flood Project Integrity and Inspection Branch (FPIIB). (DWR UCIP - O. Magana) 01/09/2014 Some sediment buildup at outlet on LS toe. (W. Wylie - DWR UCIP) FIELD_STRUCT_DESC: [Clover Creek Diversion Structure] 3 of 6: 36-inch corrugated metal drainage pipe through the levee, 12 feet below the crown. Concrete headwall on both ends. Steel slide gate plate blocks inlet on the waterside (WS) toe. (six 36-inch pipes and structure [HLM 0.3] retained under Automatic Board Order (ABO) issued as Permit No. 11507, 1975 - Lake County Flood Control and Water Conservation District). [Additional Reference(s): DWR Levee Log, 2005. USACE Sacramento O&amp;M Manual 506, Part 2, August 1961, (HLM 0.31)]. FS Date: 10/16/2019 4:04:00 PM</p>

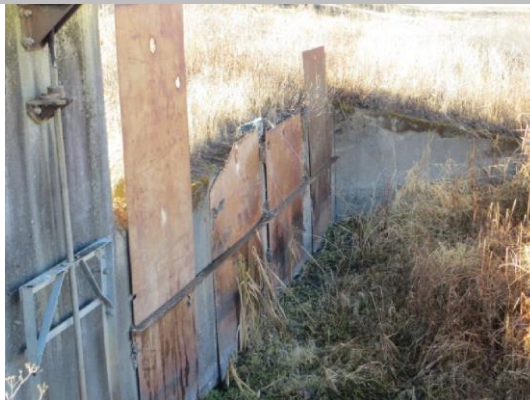
Photo 3 of 3 : UCIP\_FA\_2019\_55853\_49664.jpg

DS\_ID:21233  
FS\_ID:55853  
EP\_NO: 11507  
Repair Type: Non-Urgent  
Crossing Status: Found  
UCIP Comments: 11/20/2019 Received update from LMA representative, S. Webb, regarding the removal of the gravel bar at the Clover Creek Diversion Structure completed in late October-2019. Photos of the clearing have been uploaded. Record remains Non-Urgent; need to clarify owner for this structure. (O. Magana - DWR UCIP)10/16/2019 Crossing remains Non-Urgent due to a non-functional structure. As noted in the DWR Levee Annual Inspection report dated June 2019, significant gravel bar is impeding the flow of the channel. The new channel u/s created from the gravel reroutes low flows past the structure. According to LMA representative, S. Webb, this structure might be over designed. Mr. Webb would like to explore potential modifications to the Clover Creek Diversion Structure [six 36-inch pipes]. The proposed modification would include adding a slide gate to the most d/s pipe (designated as pipe 6) and use that one to control summer flows in conjunction the concrete weir. The pipes designated as 3, 4, and 5 (u/s to d/s, middle pipes) would not be necessary and would require proper abandonment. Pipes designated as 1 and 2 with slide gates would remain in use and would be used to allow the clear lake hitch fish to migrate u/s of the tributary. Currently, four of the six pipes without slide gates have metal sheet covering the inlet which prevent flows (flooding) from WS to LS. The structure has been designated for internal video inspection and has been scheduled for December 2019. Recommend having the CVFPB audit ABO to clarify owner. The UCIP inspection was completed with DWR Inspector, L. Dial, and DWR Sutter Yard Supervisor, S. Webb. (O. Magana - DWR UCIP)10/27/2017 This structure is inspected annually under the Structure and Channel Summer Inspection (part of the Levee Inspection Program) conducted by the DWR Flood Project Integrity and Inspection Branch (FPIIB). (DWR UCIP - O. Magana) 01/09/2014 Some sediment buildup at outlet on LS toe. (W. Wylie - DWR UCIP)

Steel slide gate visible at concrete headwall on WS toe.

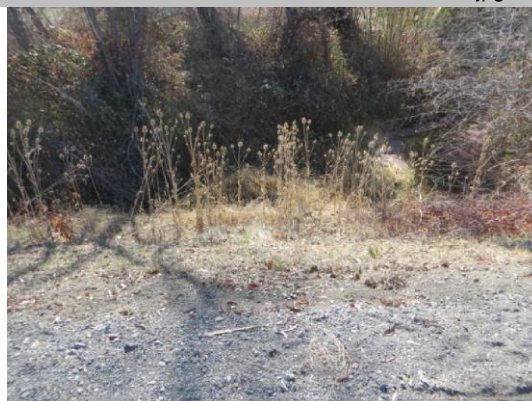
Photo 2 of 3 : UCIP\_FA\_2019\_55851\_49633.jpg

DS\_ID:21232  
FS\_ID:55851  
EP\_NO: 11507  
Repair Type: Non-Urgent  
Crossing Status: Found  
UCIP Comments: 11/20/2019 Received update from LMA representative, S. Webb, regarding the removal of the gravel bar at the Clover Creek Diversion Structure completed in late October-2019. Photos of the clearing have been uploaded. Record remains Non-Urgent; need to clarify owner for this structure. (O. Magana - DWR UCIP)10/16/2019 Crossing remains Non-Urgent due to a non-functional structure. As noted in the DWR Levee Annual Inspection report dated June 2019, significant gravel bar is impeding the flow of the channel. The new channel u/s created from the gravel reroutes low flows past the structure. According to LMA representative, S. Webb, this structure might be over designed. Mr. Webb would like to explore potential modifications to the Clover Creek Diversion Structure [six 36-inch pipes]. The proposed modification would include adding a slide gate to the most d/s pipe (designated as pipe 6) and use that one to control summer flows in conjunction the concrete weir. The pipes designated as 3, 4, and 5 (u/s to d/s, middle pipes) would not be necessary and would require proper abandonment. Pipes designated as 1 and 2 with slide gates would remain in use and would be used to allow the clear lake hitch fish to migrate u/s of the tributary. Currently, four of the six pipes without slide gates have metal sheet covering the inlet which prevent flows (flooding) from WS to LS. The structure has been designated for internal video inspection and has been scheduled for December 2019. Recommend having the CVFPB audit ABO to clarify owner. The UCIP inspection was completed with DWR Inspector, L. Dial, and DWR Sutter Yard Supervisor, S. Webb. (O. Magana - DWR UCIP)10/27/2017 This structure is inspected annually under the Structure and Channel Summer Inspection (part of the Levee Inspection Program) conducted by the DWR Flood Project Integrity and Inspection Branch (FPIIB). (DWR UCIP - O. Magana) 01/09/2014 Some sediment buildup at outlet on LS toe. (W. Wylie - DWR UCIP)

Outlet visible at concrete headwall on LS toe.

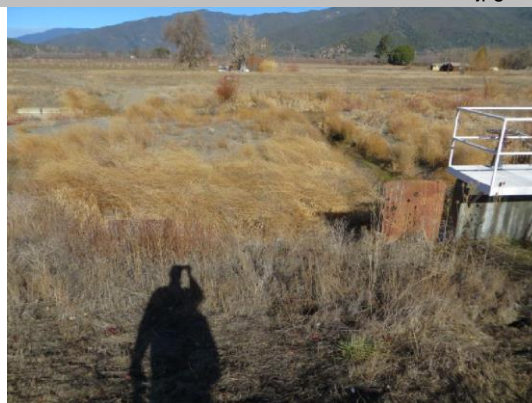
Photo 1 of 3 : UCIP\_FA\_2019\_55854\_49622.jpg

DS\_ID:21231  
FS\_ID:55854  
EP\_NO: 11507  
Repair Type: Non-Urgent  
Crossing Status: Found  
UCIP Comments: 11/20/2019 Received update from LMA representative, S. Webb, regarding the removal of the gravel bar at the Clover Creek Diversion Structure completed in late October-2019. Photos of the clearing have been uploaded. Record remains Non-Urgent; need to clarify owner for this structure. (O. Magana - DWR UCIP)10/16/2019 Crossing remains Non-Urgent due to a non-functional structure. As noted in the DWR Levee Annual Inspection report dated June 2019, significant gravel bar is impeding the flow of the channel. The new channel u/s created from the gravel reroutes low flows past the structure. According to LMA representative, S. Webb, this structure might be over designed. Mr. Webb would like to explore potential modifications to the Clover Creek Diversion Structure [six 36-inch pipes]. The proposed modification would include adding a slide gate to the most d/s pipe (designated as pipe 6) and use that one to control summer flows in conjunction the concrete weir. The pipes designated as 3, 4, and 5 (u/s to d/s, middle pipes) would not be necessary and would require proper abandonment. Pipes designated as 1 and 2 with slide gates would remain in use and would be used to allow the clear lake hitch fish to migrate u/s of the tributary. Currently, four of the six pipes without slide gates have metal sheet covering the inlet which prevent flows (flooding) from WS to LS. The structure has been designated for internal video inspection and has been scheduled for December 2019. Recommend having the CVFPB audit ABO to clarify owner. The UCIP inspection was completed with DWR Inspector, L. Dial, and DWR Sutter Yard Supervisor, S. Webb. (O. Magana - DWR UCIP)10/27/2017 This structure is inspected annually under the Structure and Channel Summer Inspection (part of the Levee Inspection Program) conducted by the DWR Flood Project Integrity and Inspection Branch (FPIIB). (DWR UCIP - O. Magana) 01/09/2014 Some sediment buildup on LS toe. (W. Wylie - DWR UCIP) FIELD\_STRUCT\_DESC: [Clover Creek Diversion Structure] 5 of 6: 36-inch corrugated metal drainage pipe through the levee, 12 feet below the crown. Concrete headwall on both ends. Steel slide gate blocks inlet on the waterside (WS) toe. (six 36-inch pipes and structure [HLM 0.3] retained under Automatic Board Order (ABO) issued as Permit No. 11507, 1975 - Lake County Flood Control and Water Conservation District). [Additional Reference(s): DWR Levee Log, 2005. USACE Sacramento O&M Manual 506, Part 2, August 1961, (HLM 0.31)]. FS Date: 10/16/2019 4:06:00 PM

Metal slide gate visible at concrete headwall on WS toe.

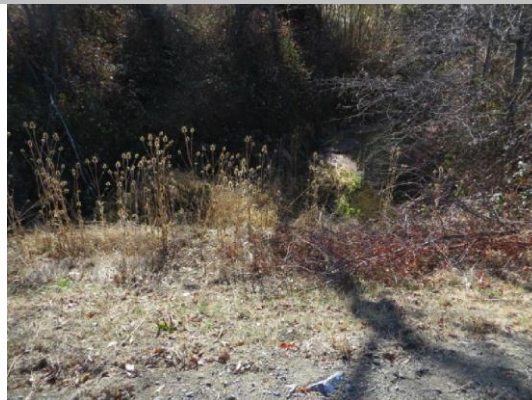
Photo 2 of 3 : UCIP\_FA\_2019\_55854\_49621.jpg

Pipe visible at concrete headwall on LS toe.

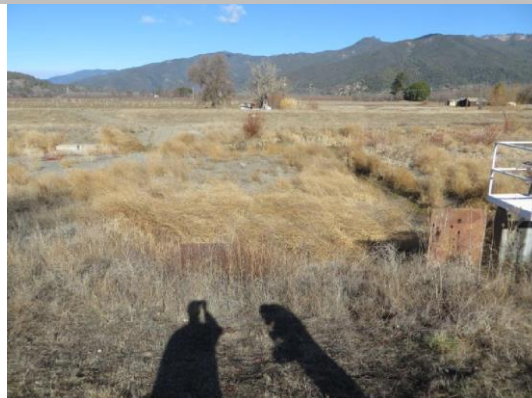
Photo 1 of 3 : UCIP\_FA\_2019\_55341\_49610.jpg

Comment Code					
Inspector Comment					
DS_ID:21229 FS_ID:55341 EP_NO: 11507 Repair Type: Non-Urgent Crossing Status: Found UCIP Comments: 10/16/2019 (O. Magana - DWR UCIP)10/27/2017 This structure is inspected annually under the Structure and Channel Summer Inspection (part of the Levee Inspection Program) conducted by the DWR Flood Project Integrity and Inspection Branch (FPIIB). (DWR UCIP - O. Magana) 01/09/2014 Some sediment buildup at outlet on LS toe. (W. Wylie - DWR UCIP) FIELD_STRUCT_DESC: [Clover Creek Diversion Structure] 6 of 6: 36-inch corrugated metal drainage pipe through the levee, 12 feet below the crown. Concrete headwall on both ends. Steel slide gate covers waterside (WS) inlet. (six 36-inch pipes and structure [HLM 0.3] retained under Automatic Board Order (ABO) issued as Permit No. 11507, 1975 - Lake County Flood Control and Water Conservation District). [Additional Reference(s): DWR Levee Log, 2005. USACE Sacramento O&M Manual 506, Part 2, August 1961, (HLM 0.31)]. FS Date: 10/16/2019 4:06:57 PM

Steel slide gate visible at headwall on WS toe.

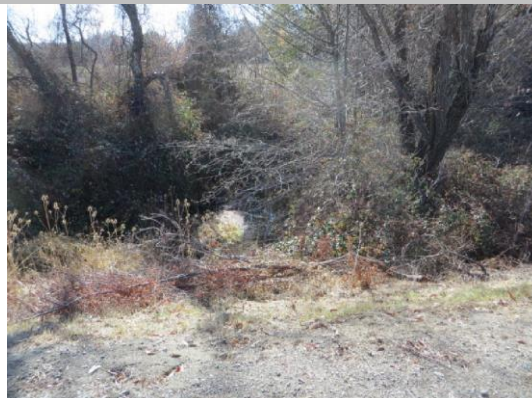
Photo 2 of 3 : UCIP\_FA\_2019\_55341\_49609.jpg

Concrete headwall on LS toe.

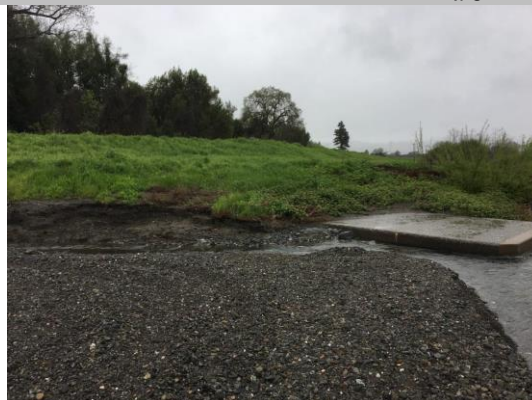
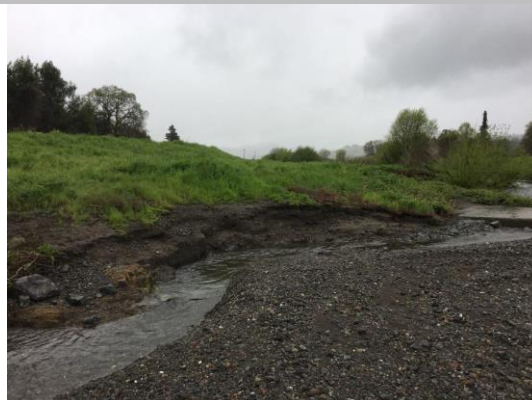
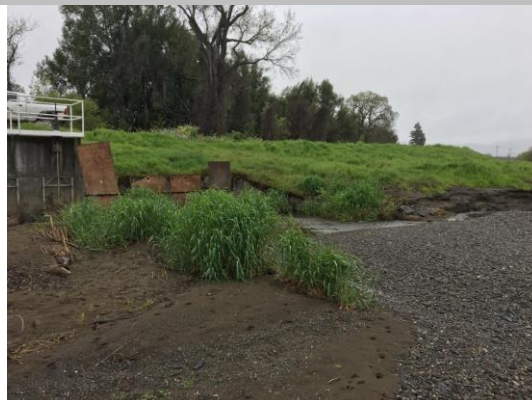
LM Start	0.32	Rating **	A/W	Issue No.	13
LM End	0.32	Issue Type +	Ma	Location *	LS
Category	Supplemental			GPS Latitude/Longitude	
				Start	End
Item	2017 Storm Damage			39.177150 °	39.177150 °
				-122.899111 °	-122.899111 °
DWR ID	LCWPD-01				
Comment Code					
Inspector Comment					
Levee Evaluation Comments					
Description:					
Site ID No:19					
Site Designation:LCWPD-01					
Repair Type: Erosion					
Rating: Area of Concern					
Field Date:6/5/2017					
Notes: Erosion exists between a small weir and diversion pipes. Spring 2019 DWR Inspection: Headwall and pipes appear to be intact.

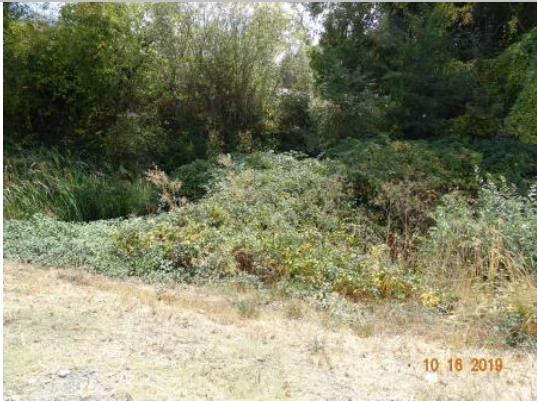
Photo 1 of 1 : FA\_2019\_NA0009\_7\_16\_20191021\_00031.jpg

View of wild growth at the landside toe near the diversion outlet. Fall 2019

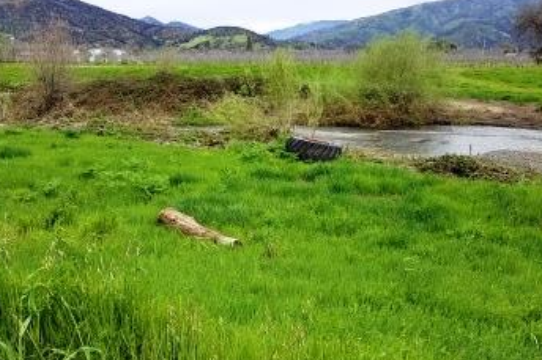
Photo 1 of 1 : FA\_2019\_NA0009\_7\_17\_20190904\_00005.jpg

View of large tire and tree log in the waterway. Spring 2019

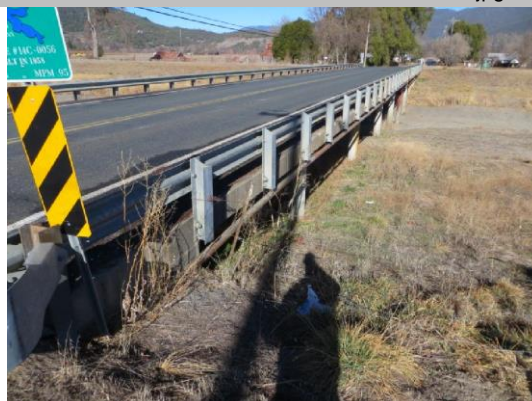
Photo 1 of 3 : UCIP\_FA\_2019\_55818\_49593.jpg

Comment Code					
Inspector Comment					
DS_ID:21230 FS_ID:55818 EP_NO: 6303A Repair Type: Non-Urgent Crossing Status: Found UCIP Comments: 10/16/2019 Record remains Non-Urgent; crossing has been abandoned. Owner will need to coordinate with CVFPB to remove or abandon crossing per Title 23 requirements. The UCIP inspection was completed with DWR Inspector, L. Dial, and LMA representative, S. Webb. (O. Magana - DWR UCIP)01/09/2014 Pipe plugged on WS near bridge centerline. (W. Wylie - DWR UCIP) FIELD_STRUCT_DESC: 4-inch steel irrigation pipe through the levee, 1.5 feet below the crown. Steel cutoff wall around pipe at center of levee. Pipe connects to 4-inch exposed aluminum pipe visible on upstream side of bridge. (4-inch water pipe authorized through both levees and suspended from the bridge authorized under Permit No. 6303-A, 1968 - John M. Siseuich). [Additional Reference(s): DWR Levee Log, 2005]. FS Date: 10/16/2019 4:07:00 PM

Aluminum irrigation pipe visible on upstream side of bridge.

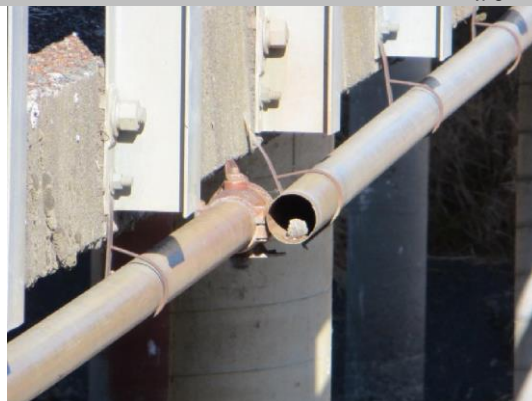
Photo 2 of 3 : UCIP\_FA\_2019\_55818\_49592.jpg

Aluminum irrigation pipe visible on upstream side of bridge.

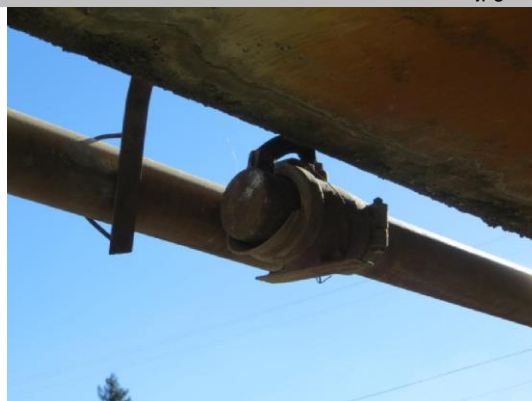
Photo 3 of 3 : UCIP\_FA\_2019\_55818\_49591.jpg

Aluminum pipe plugged near center of bridge.

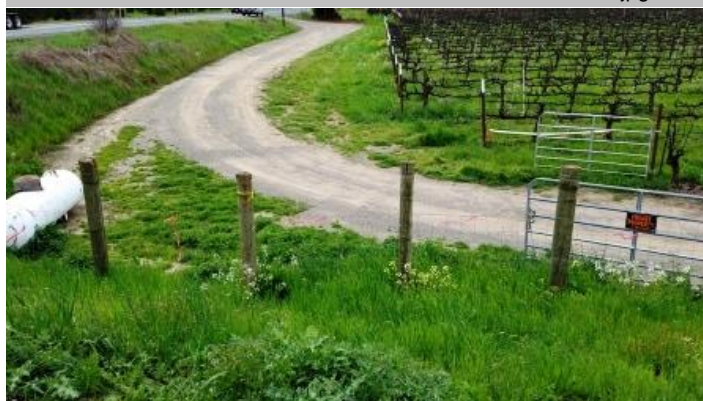
Photo 1 of 1 : FA\_2019\_NA0009\_7\_23\_20190904\_00011.jpg

LM Start	<b>0.55</b>	Rating **	M	Issue No.	<b>23</b>							
LM End	<b>0.55</b>	Issue Type +	En	Location *	LS							
Category	Earthen Levee		GPS Latitude/Longitude									
			Start	End								
Item	Encroachments		39.175702°	39.175702°								
			-122.902881°	-122.902881°								
DWR ID	DWR_NA0009_05_s_2019_23											
Comment Code												
EQ : Equipment												
Inspector Comment												
The propane tank at the levee toe does not appear to be authorized.

View of propane tank located at levee toe. Spring 2019

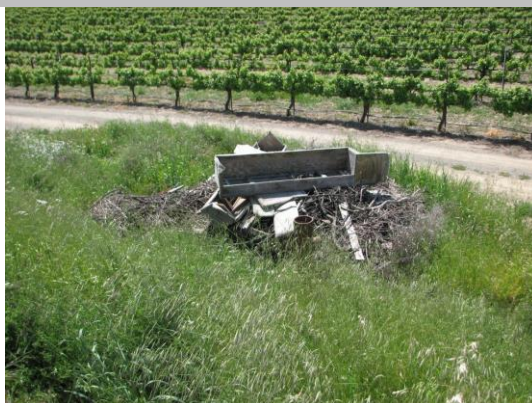
Photo 1 of 1 : FA\_2019\_NA0009\_7\_10\_20190904\_00001.jpg

LM Start	<b>0.63</b>	Rating **	M	Issue No.	<b>10</b>							
LM End	<b>0.63</b>	Issue Type +	En	Location *	LS							
Category	Earthen Levee		GPS Latitude/Longitude									
			Start	End								
Item	Encroachments		39.175758°	39.175758°								
			-122.904353°	-122.904353°								
DWR ID	DWR_NA0009_05_s_2016_10											
Comment Code												
DE : Debris												
Inspector Comment												
Remove prunings and lumber debris.

5/2/2016: Remove prunings and lumber debris from L/S toe.

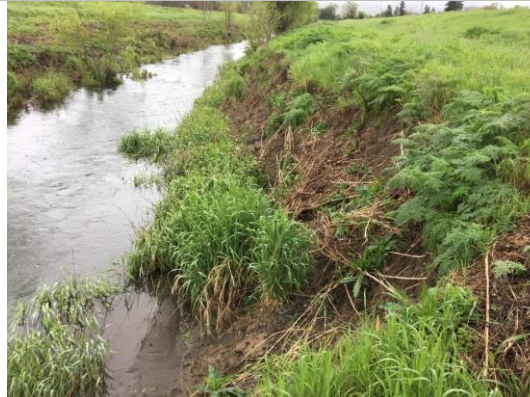
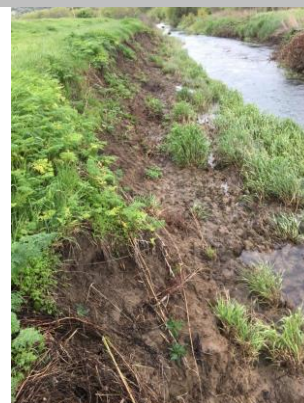
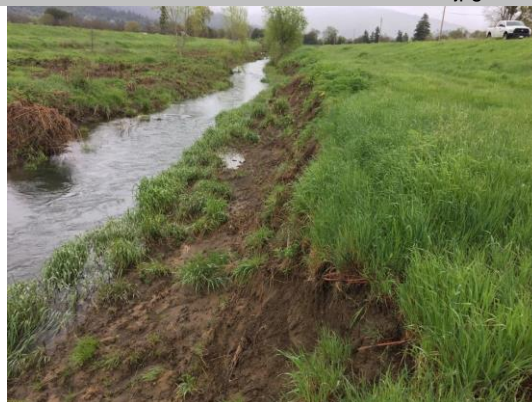
LM Start	<b>0.82</b>	Rating **	A/W	Issue No.	<b>20</b>
LM End	<b>0.86</b>	Issue Type +	Ma	Location *	WS
Category	Supplemental		GPS Latitude/Longitude		
			Start	End	
Item	2017 Storm Damage		39.175740°	39.175750°	
			-122.907980°	-122.908710°

View of new erosion downstream. Spring 2019
